BAKER (MICHAEL) JR INC BEAVER PA
NATIONAL DAM SAFETY PROGRAM, BUFFALO RIVER NUMBER 2 JAMES RIVER--ETC(U)
SEP 79

NAME OF DAM: BUFFALO RIVER No. 2

PHASE I INSPECTION REPORT
NATIONAL DAM SAFETY PROGRAM
NAME OF DAM: BUFFALO RIVER No. 2 ID #VA 00912

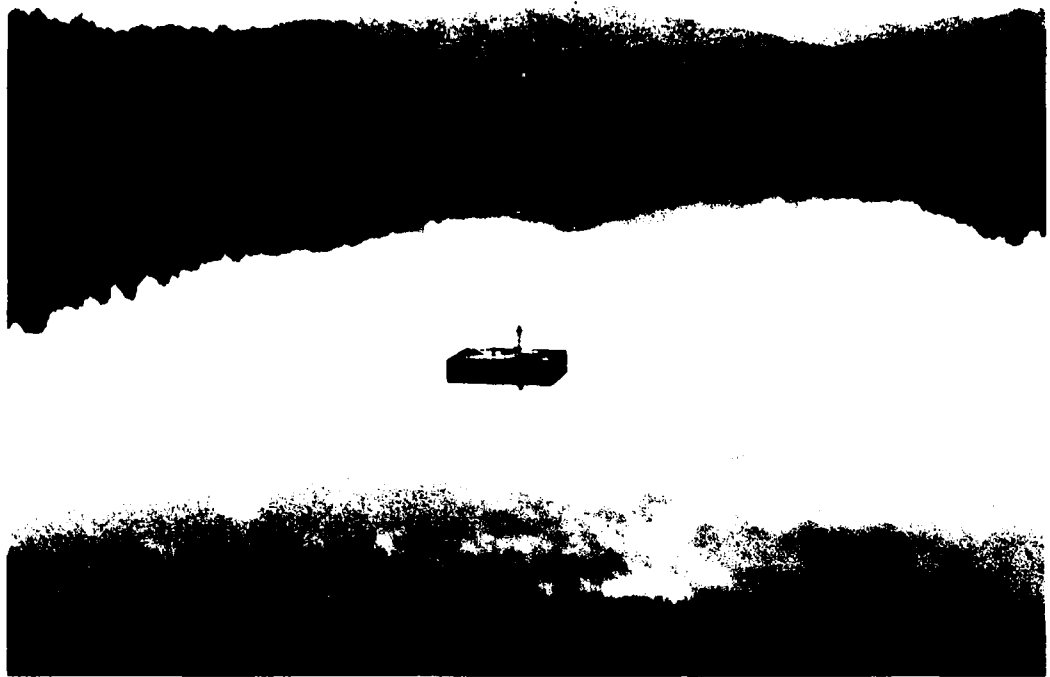
PHOTO 5. View of Riser and Reservoir from Crest of Dam

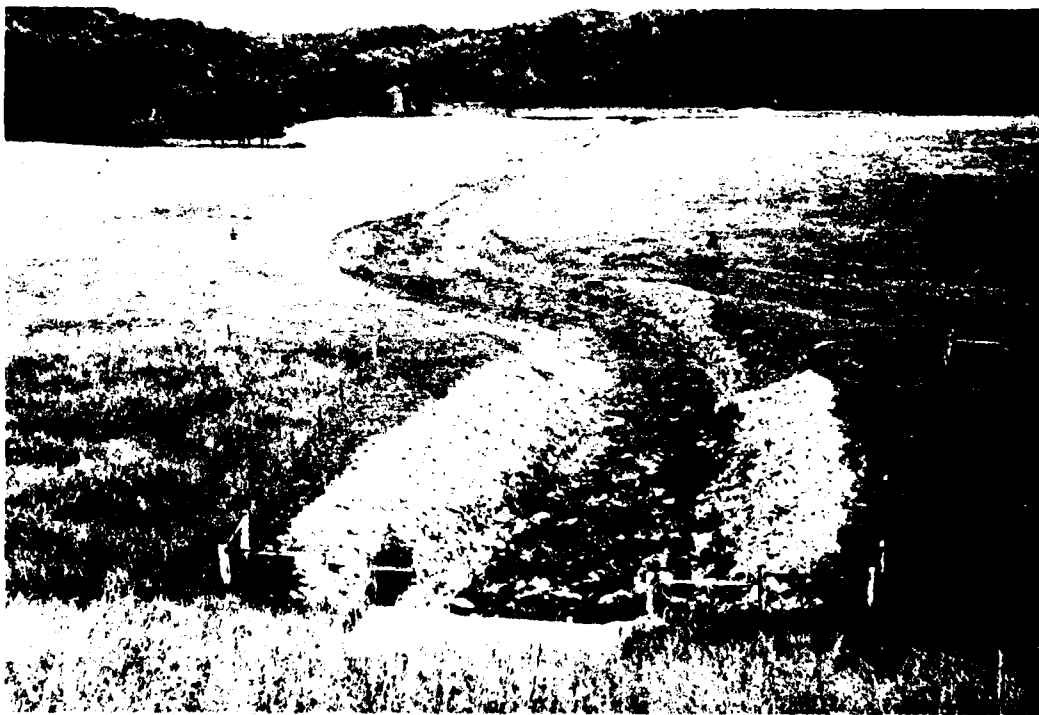
PHOTO 8. Downstream Area with VA Route 610 and Farmhouse in Background
